Ärendenummer
NV Rapport 2024-03

Projekt
SmartInfra

Microbiologically influenced corrosion

Smart monitoring of infrastructure asset health and performance in drinking water distribution systems

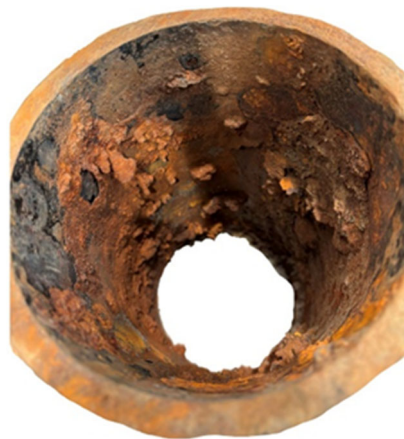
Figure 1: Cast iron pipe that was installed in 1910 in Norrvatten's DWDS.

Corrosion cause failure in metallic structures that are essential for drinking water distribution. Metal pipes may deteriorate due to build-up of iron, inducing loss of pressure and altered flow in the distribution (Figure 1). The corrosion products that build up on pipe walls may function to inhibit further corrosion but extensive build-up alters water-flow (Svenskt Vatten P115). Such a thick build-up may also function as reservoir for a wide array of microorganisms, some potentially harmful, in biofilm (Xin et al. 2023; Wingender & Flemming. 2011). Concrete and cement structures with metal reinforcement may break due to corrosion. Furthermore, iron may be released into bulk water and cause aesthetic

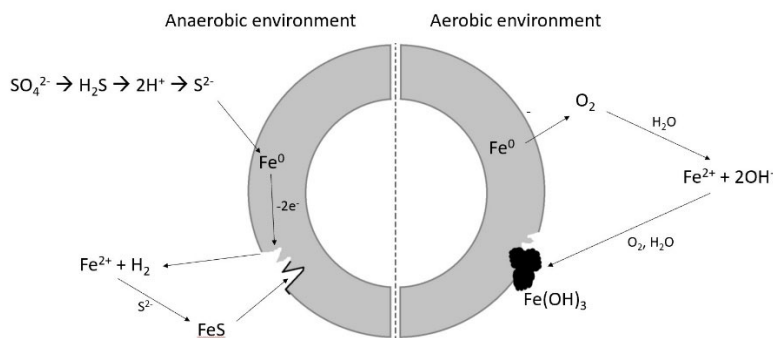
Figure 2: Basic principles of MIC mechanisms under aerobic and anaerobic conditions (derived from Kadukova & Pristas. 2018). Iron(II) sulfide in anaerobic environment and iron(III) hydroxide in aerobic environment.
